PULLEYS GET THINGS MOVING. **ORIGINAL PARTS TAKE YOU FURTHER.**

CORTECO makes it easy to replace a pulley!

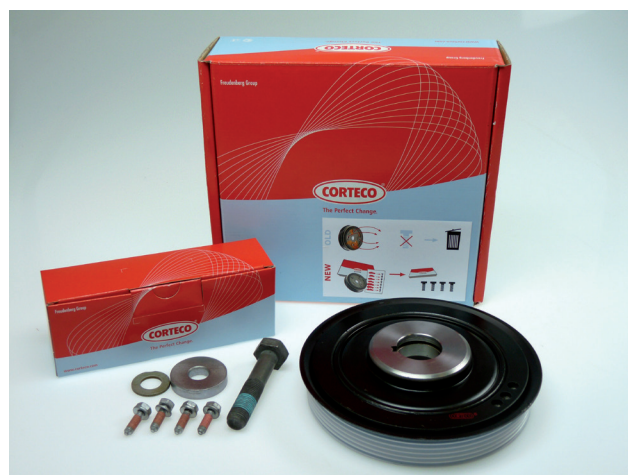
Danger: Vibration damage

Failure to replace the pulley at regular intervals or the use of parts which are not original quality carries the risk of vibration damage and increased noise levels. Vibration caused by a pulley which is old, or of poor quality, can damage the auxiliary units. This can lead to engine damage or engine failure.

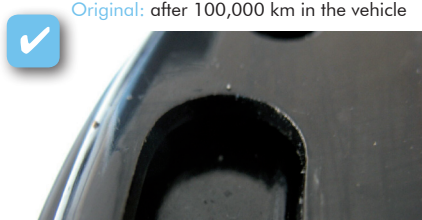
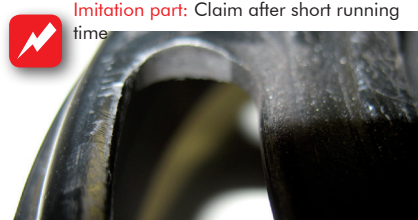
Simple visual checks can reveal the following types of damage:

- Fissures in the elastomer material
- Damages to the belt
- Worn fastening (deformation)

The biggest vibrations occur when changing from idling to full load. The following points have to be checked:

- Belt vibration
- Vibration of the belt tensioner
- Creation of noise

With excessive vibration comes the risk that the belt will tear, which can ultimately lead to engine damage.
